**Proceedings of the Workshop on  
Watershed Degradation and Restoration of the Lam Phachi  
River Basin, Thailand**

**Held at Bangkok, November 29, 2002**

**Proceedings of the Workshop on  
Watershed Degradation and Restoration of the Lam Phachi  
River Basin, Thailand Held at Bangkok, November 29, 2002**

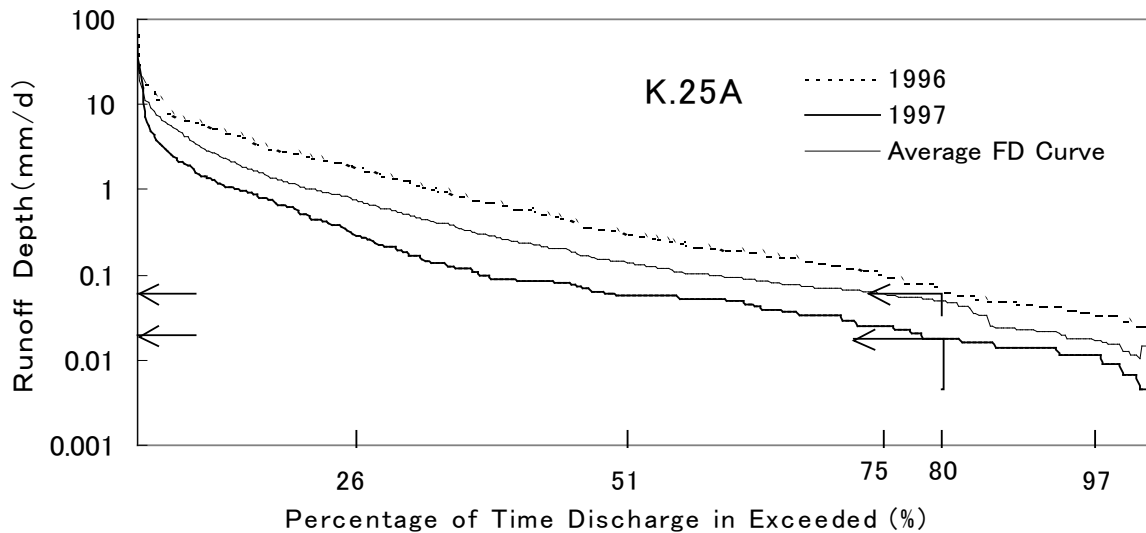
Figure 5. Flow duration curve for K.25A site.

The Flow duration curves for K.25A site are shown in Figure 5. This figure is drawn with discharge arranged in order of descending magnitude. The magnitude of stream discharge is plotted as ordinate against the corresponding percent of time, the probability that an arbitrary discharge will be equaled or exceeded, as abscissas. The average FD curve is constructed using daily discharge of successive years. From this figure, the runoff depth exceeded 80 percent of time, recognized as an index of low flows in Thailand, is 0.06 mm/d in rainy water year, 0.02 mm/d in drought year. These values are small because the persistence of flow in this study area is low (Figure 4,  $\lambda = 0.025(d-1)$ ). And that difference is about three times, demonstrating that flow regime is dependent on the amount of annual rainfall.

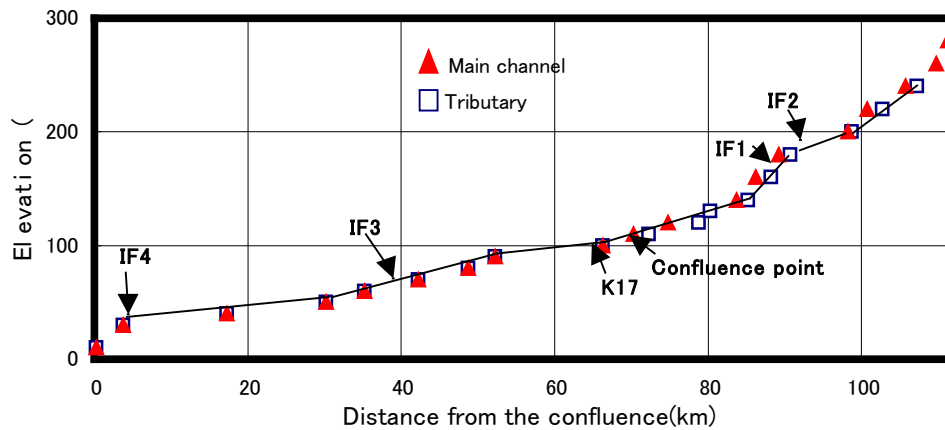
Fig. 2 Longitudinal profile of the Lam Phachi River

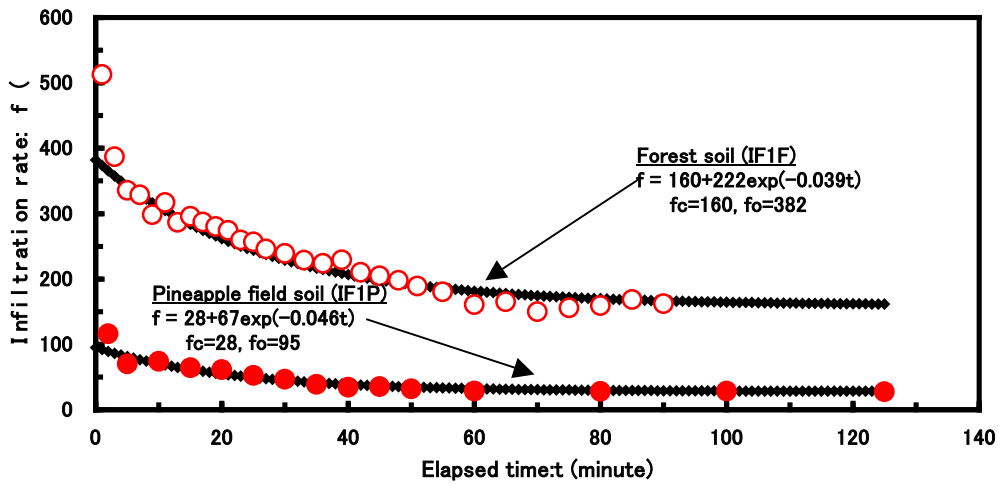
Fig. 10 Infiltration capacity curves of the forestland and the pineapple field at the IF1 site  
 f: Horton equation,  $f_c$ : final rate,  $f_o$ : initial rate

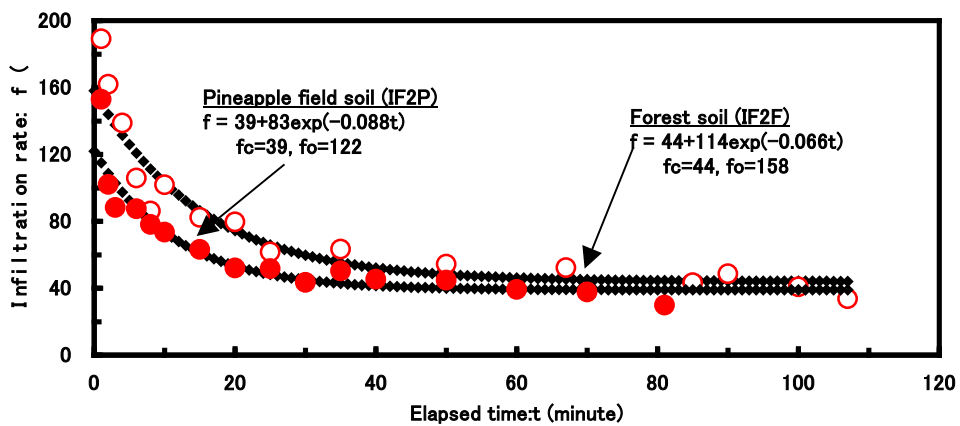
Fig. 11 Infiltration capacity curves of the forestland and the pineapple field at the IF2 site  
 f: Horton equation,  $f_c$ : final rate,  $f_o$ : initial rate

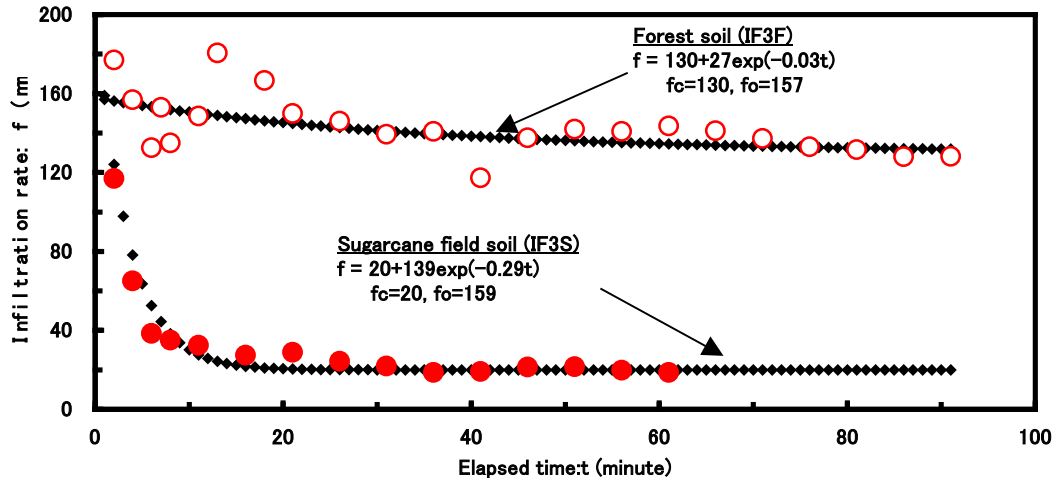
Fig. 12 Infiltration capacity curves of the forestland and the sugarcane field at the IF3 site  
 f: Horton equation,  $f_c$ : final rate,  $f_o$ : initial rate

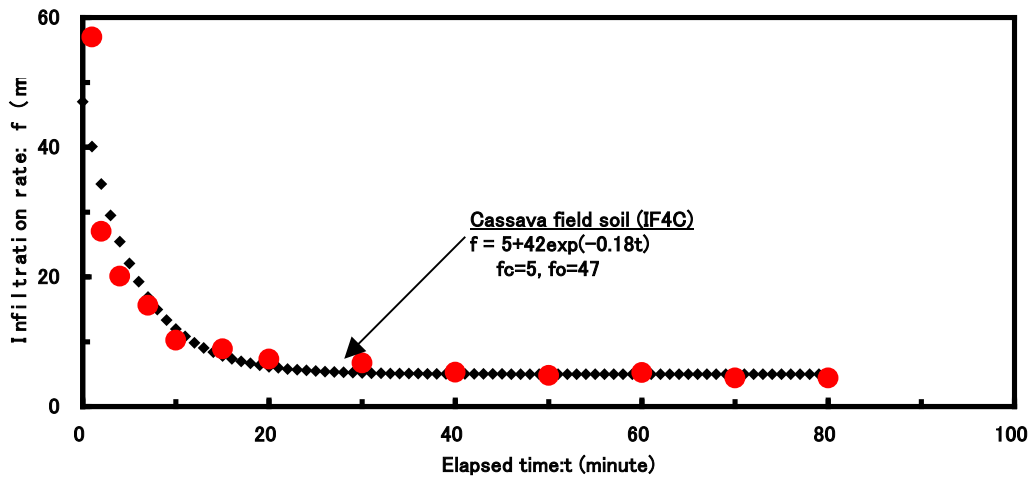
Fig. 13 Infiltration capacity curve of the cassava field at the IF4 site  
 f: Horton equation,  $f_c$ : final rate,  $f_o$ : initial rate

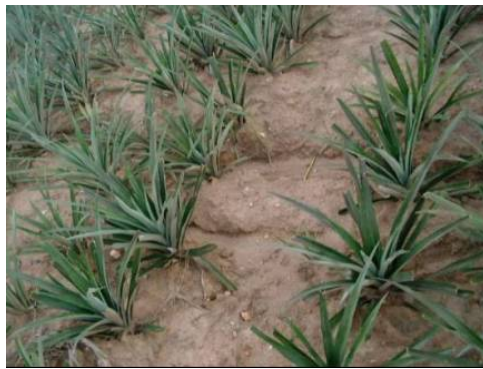
Fig. 16 Rill erosion at the pineapple field of one year growth (EP1)

The mean width of rills and gullies in the EP1 (EP2) plot is 0.55 m (0.76 m). The mean depth of rills and gullies in the EP1 (EP2) plot is 0.12 m (0.31 m)(Table 1). Considering the range of width and depth (Table 1), rill erosion in the first-year-growth pineapple field caused by the rainfall of the first rainy season could develop into gully erosion by the rainfall of the second and the third rainy season. This change could promote the extension and the connection of rills and/or gullies and result in higher density of rills and gullies (Figs. 16 and 17, Table 1). If we divide the volume of rill and gully at the EP1 and the EP2 plots by the number of rainy seasons, we can roughly estimate the annual soil erosion. Thus we estimated the soil erosion rate at the EP1 plot to be 49.4 m<sup>3</sup>/ha/yr and that at the EP2 plot to be 116.3 m<sup>3</sup>/ha/yr (Table 1). These soil erosion rates also can be shown to be 69 t/ha/yr (EP1) and 163 t/ha/yr (EP2) if the bulk density of the soil is assumed to be 1.4 t/m<sup>3</sup>.

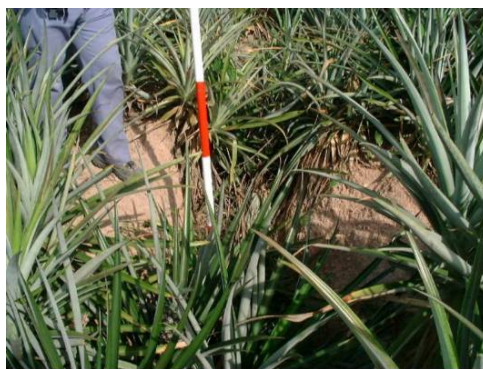
●—● Rill erosion, ..... Middle of planting rows

Figure 16 shows rill erosion at the EP1 plot, a one-year growth pineapple field with 11 percent maximum slope, and Fig. 17 shows rill and gully erosion at the EP2 plot, a three-year growth pineapple field with 18 percent maximum slope. Both plots are selected in the most severe soil erosion area in the target research area. The pineapple growth age is a time indicator showing how often its field experienced rainy seasons, and when the soil erosion in its field began. Every three years, old pineapples are removed from the fields, and simultaneously field

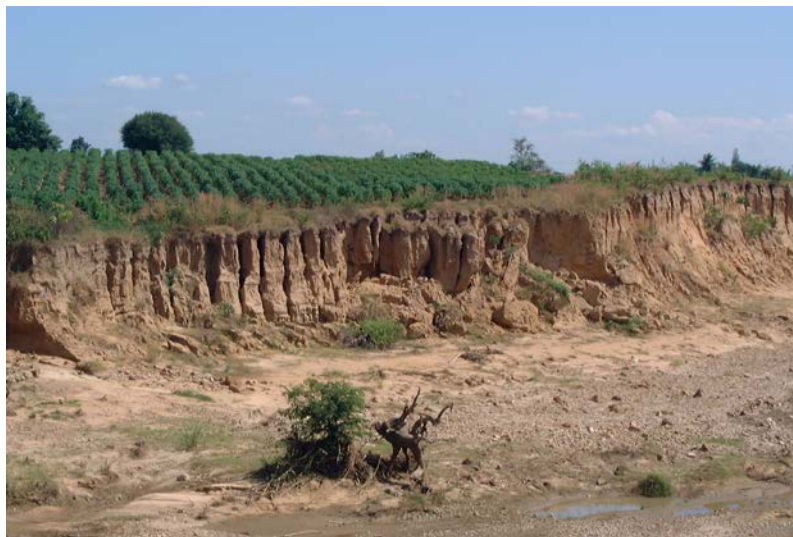
Photo 1 Bank erosion caused by inappropriate agricultural practices near the IF4 site

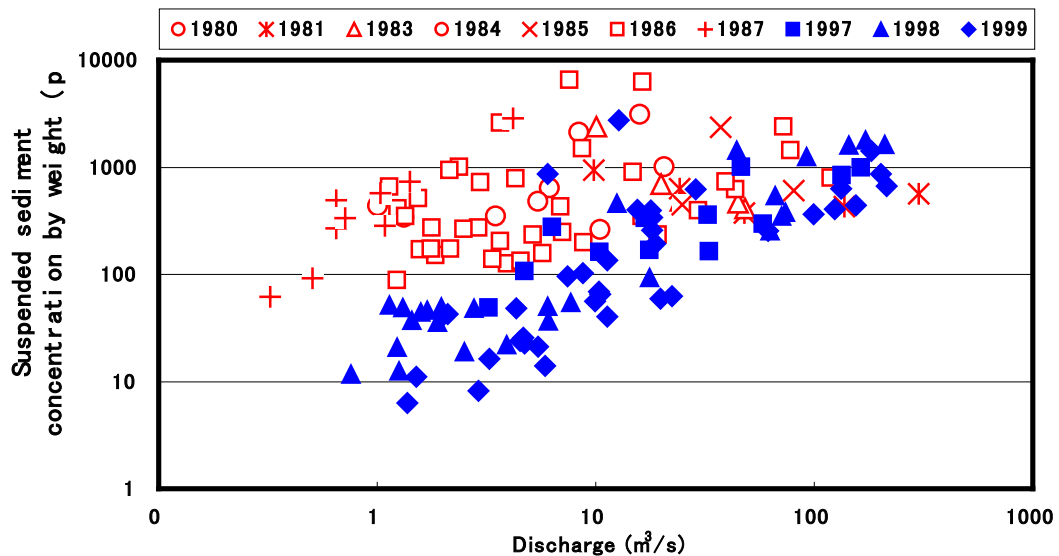
Fig. 20 Comparison of the suspended sediment concentration in the 1980s with the 1990s

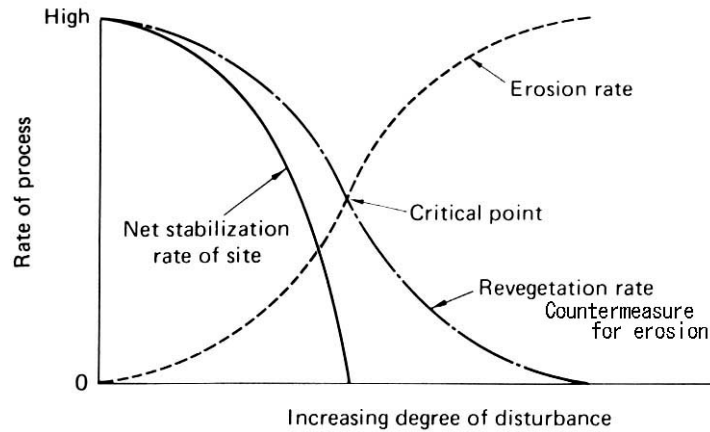
Fig. 21 Relationship of deterioration of a site by erosion to the rate of revegetation and countermeasure for soil erosion

deterioration. A vicious cycle is initiated that reduces favorable plant growth conditions to a minimum, while erosion rates reach their maximum. Once the critical point in deterioration is exceeded, the cycle is carried to completion with the removal of the soil mantle unless people intervene to reverse the process (Satterlund and Adams, 1992).

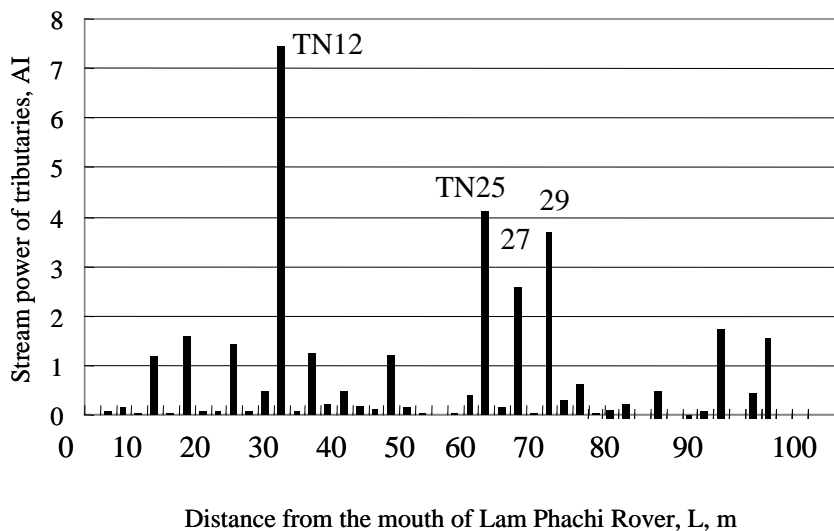
**Figure 3. Calculated stream power of each tributary.**

Figure 3 shows the calculated stream power of each tributary. Indices of stream power,  $A \cdot I$ , indicate large values at the joining points of tributaries, TN12, TN25, TN 27 and TN 29, respectively. Except for TN3, these points are coincident with the joining points with large catchment as shown in Figure 2. Therefore in Lam Phachi River, increasing in stream power yielded from tributaries can result to owe not to slope but to catchment size.

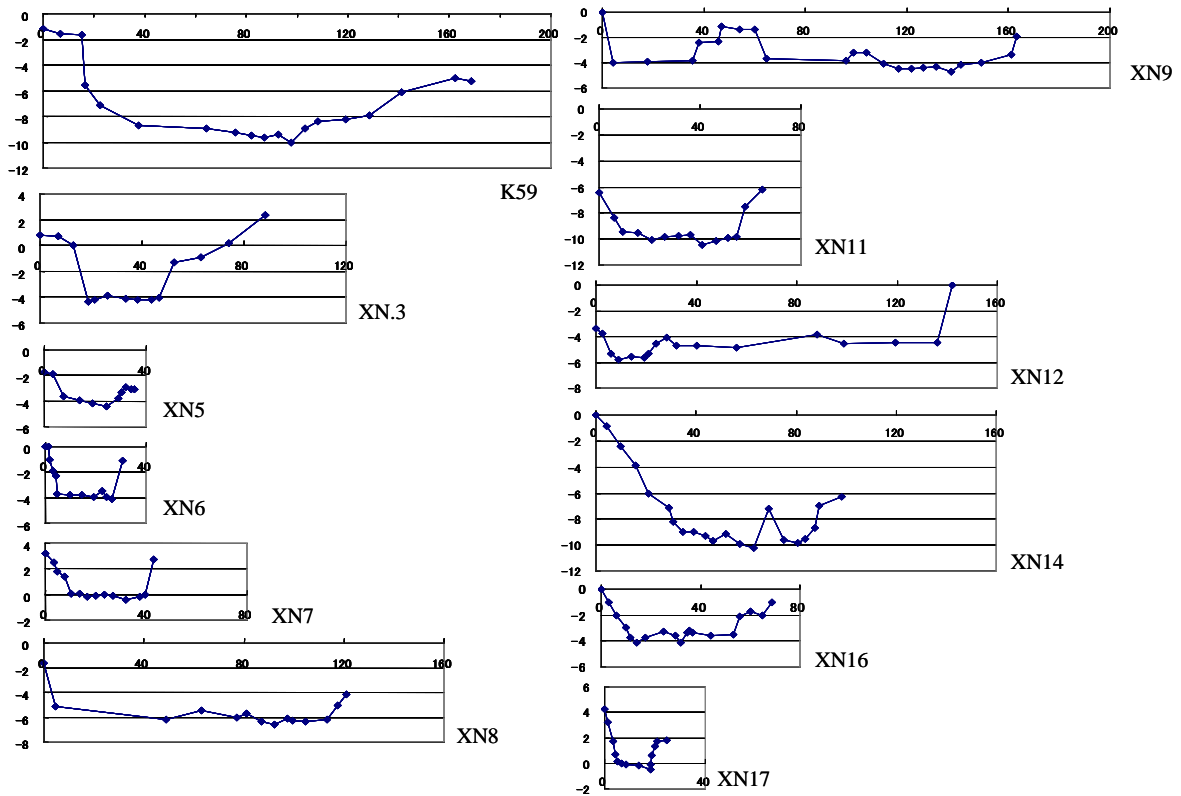
**Figure 4. Cross section along Lam Phachi main channel**

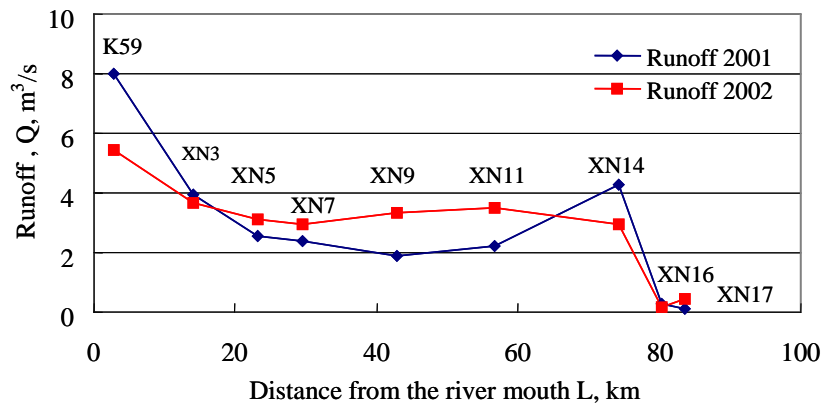
**Figure 5. Low water runoff along the main channel of Lam Phachi River.**

Runoff measuring at the low water was conducted twice in summer of 2001 and 2002 at the same water cross section. The results are shown in Figure 5. Both changes in runoff along the main channel are similar. After runoff,  $Qm^3/s$ , quickly increases at the junction, XN14, with large tributary, they keep going constantly or slightly decrease. The runoff begins to increase again at the lower reach from XN5 (TN7; 30km from the mouth). Although cumulative catchment area increase downstream of main channel (Fig. 2), changes in low water runoff are not affected by the geomorphologic nature.

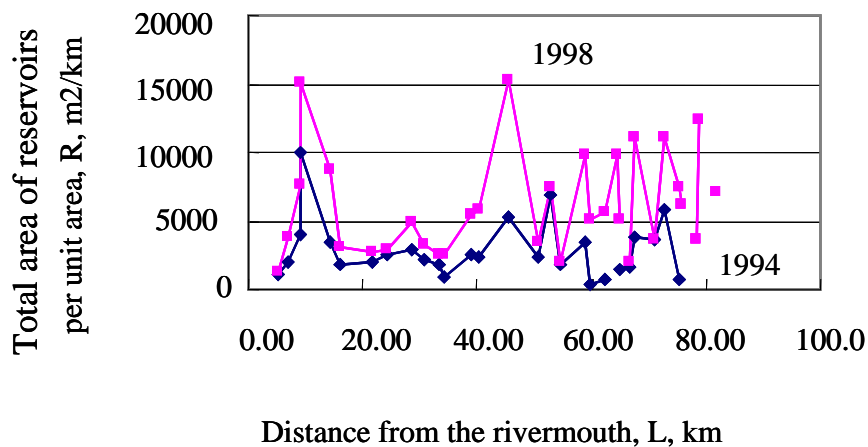
**Figure 8. Longitudinal changes in total area of reservoirs per unit catchment area, with comparing between 1998 and 1994 air photos.**

Figure 8 shows longitudinal changes in total area of reservoirs per unit catchment area of tributaries. Because the air photos does not always cover an entire tributary catchment and reservoir measuring was done in a part of catchment, the result surveyed should be calculated as totalized reservoir area per unit catchment area. Comparing air photos taken in 1994 with them in 1998, the area of reservoirs increased at any tributary catchments. In the upper reach of the 40km point from river mouth, area of reservoirs much more increased.

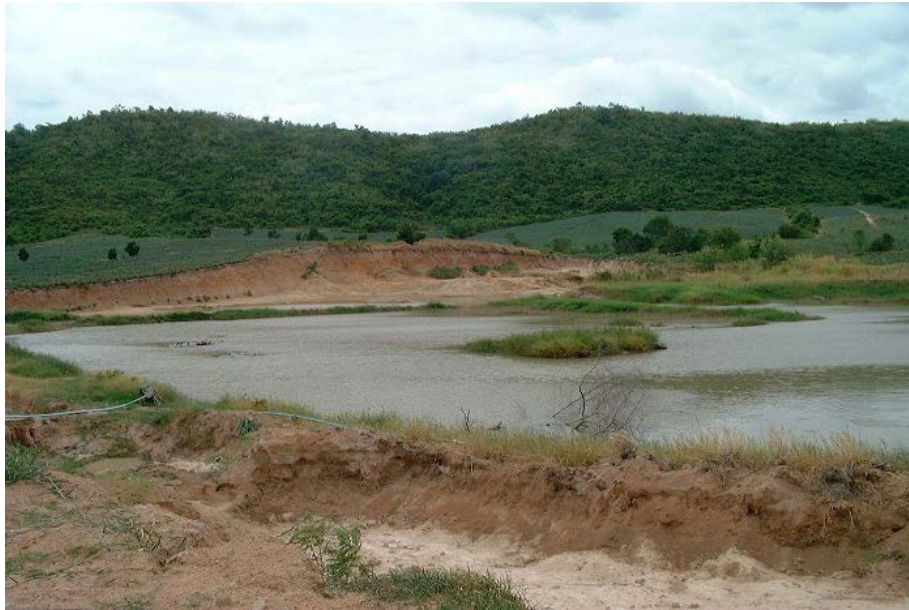
**Photo 1. Reservoir excavated in a tributary catchment by local farmers.**

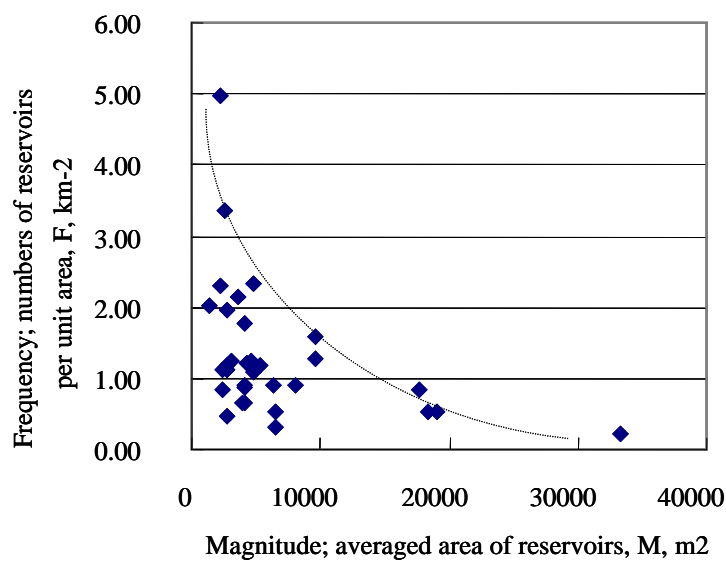
**Figure 9. Frequency-magnitude analysis of reservoirs**

At last, to characterize the significant tributaries, the relationship between magnitude and frequency analysis of reservoir distributions in tributary catchments is shown in Figure 9. Magnitude is defined as averaged area of reservoirs in each tributary catchment, and frequency is done by numbers of reservoirs per unit catchment area. The graph shows the hyperbolic relation between magnitude and frequency of reservoirs. That is, many reservoirs distribute with small size, and large-sized reservoirs distribute with isolating. The tendency of magnitude-frequency relation of reservoirs can be provided from the agricultural demand of water resource balance managed by local peoples.

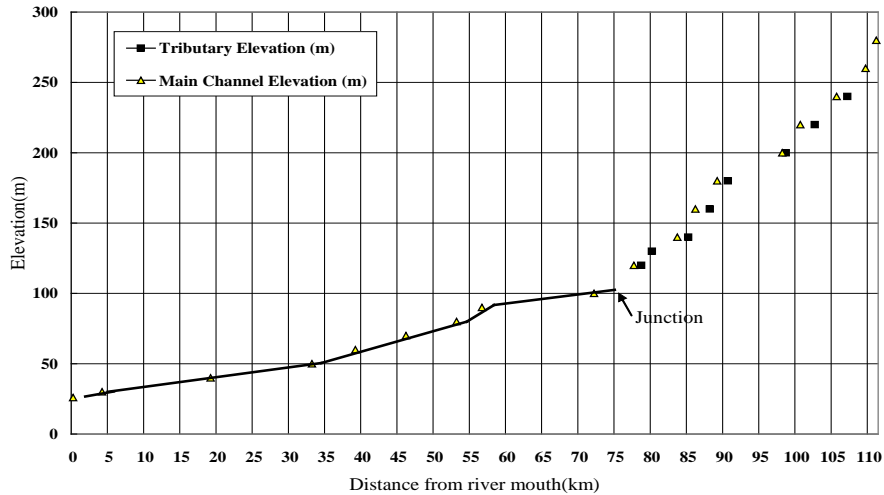
Fig. 6 Longitudinal profile for Lam Phachi River

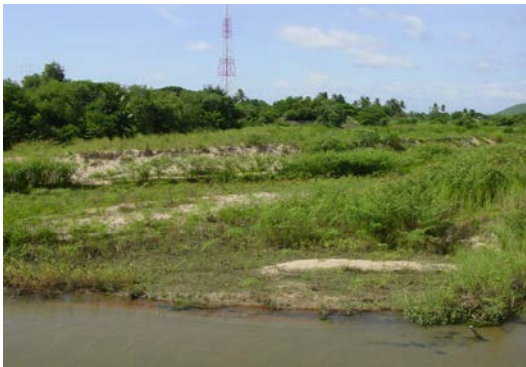
Photo 3 Vegetation cover on terraces

The reaches with terrace deformation upstream could therefore be pointed out as the main source of sediment yield, located from 44 to 60 km. In 1974 the distribution of existing wide terraces was limited to the upper reaches from 43km, but in 1998 it extended downstream until the 30 km point. After the floods which resulted in the deformation of terraces, vegetation has thrived quickly and recovered on the surface of the terrace within a short time (Photo 3, 4). With vegetation cover, the terraces appear to be stable, but in actual fact they are unstable and likely to move again.

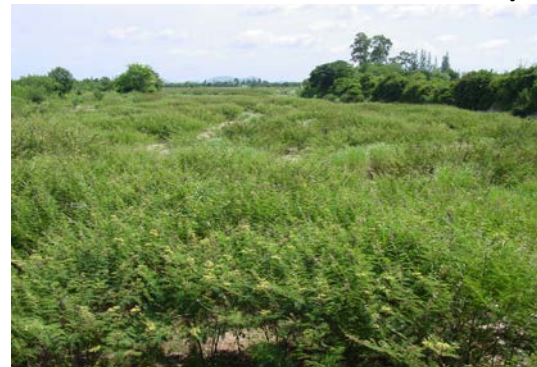
Photo 4 Vegetation cover on river-bed

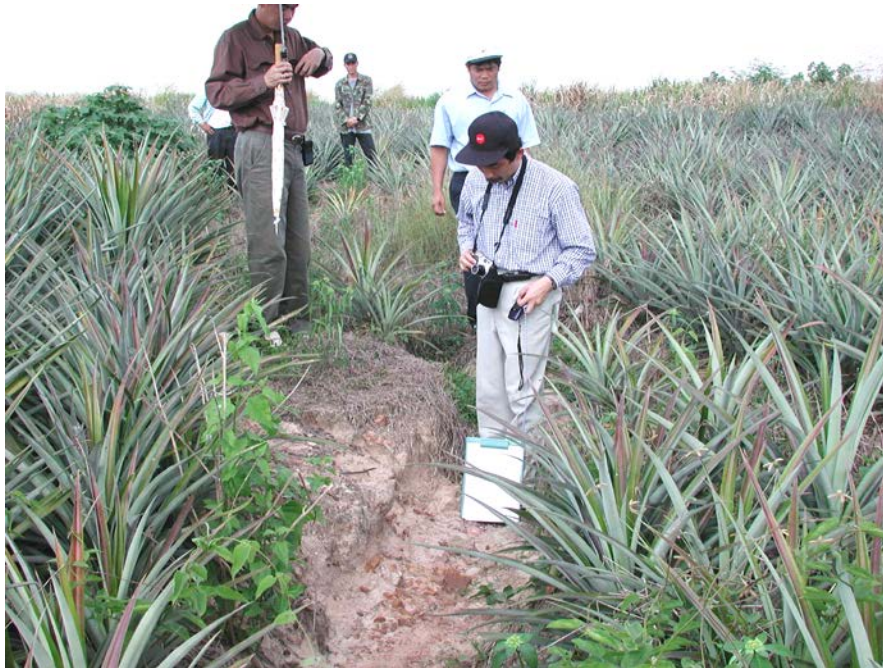
Fig. 5.1 Soil erosion in a pineapple field with a gradient of 4°

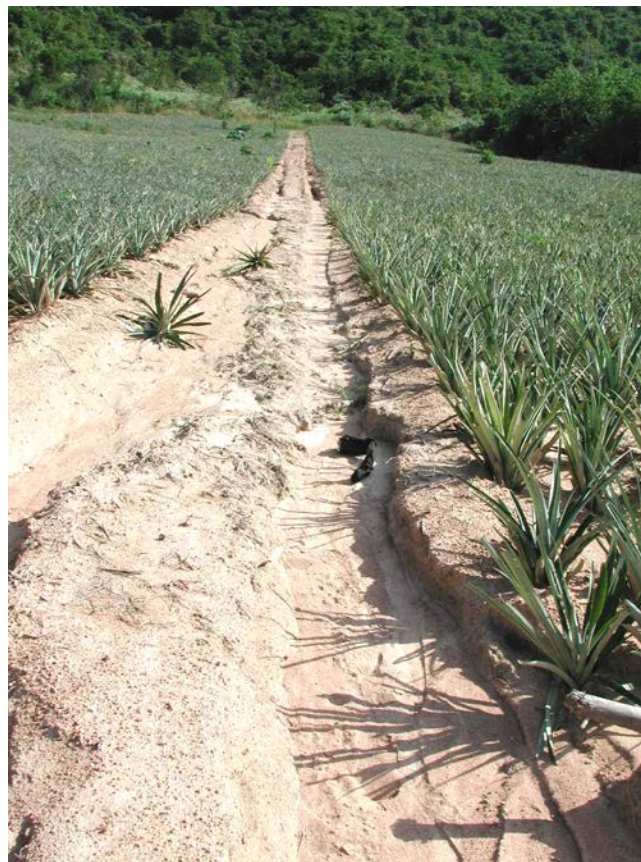
Fig. 5.2 Soil erosion in a pineapple field with a gradient of 6°

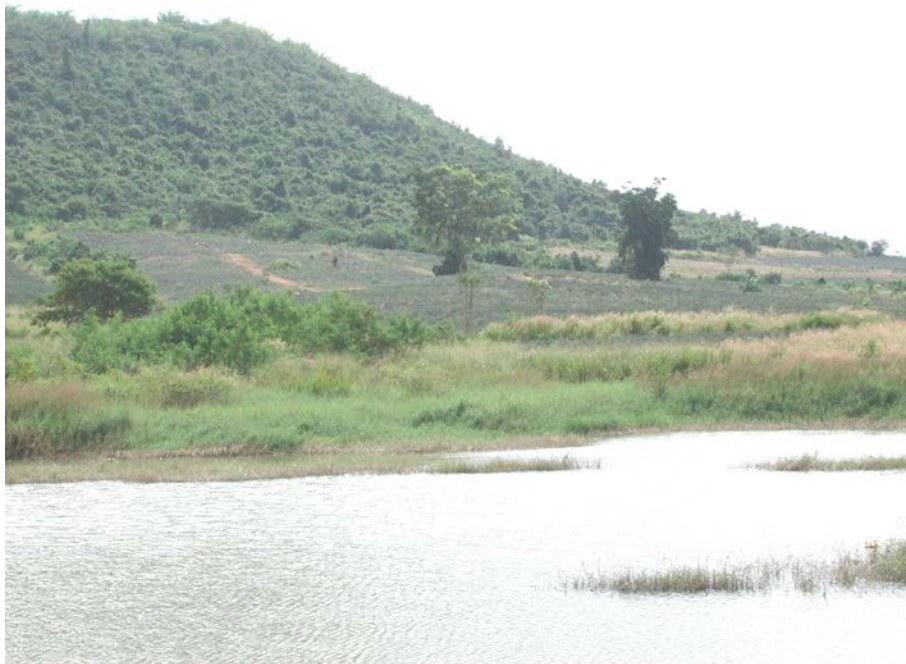
Fig. 5.3 The pond near the pineapple field in the Fig.5.2

Soils are eroded in some pineapple fields around the gauging station K 25A. Fig. 5.1 and Fig. 5.2 show soil erosion in two pineapple fields. The eroded soil from the pineapple field in Fig. 5.2 flows into the pond shown in Fig. 5.3 and accumulates at its bottom. Figure 5.4 shows that eroded soil flowed from the road of the foreground side to the weed-grown side where eroded soil flowed into the pond.

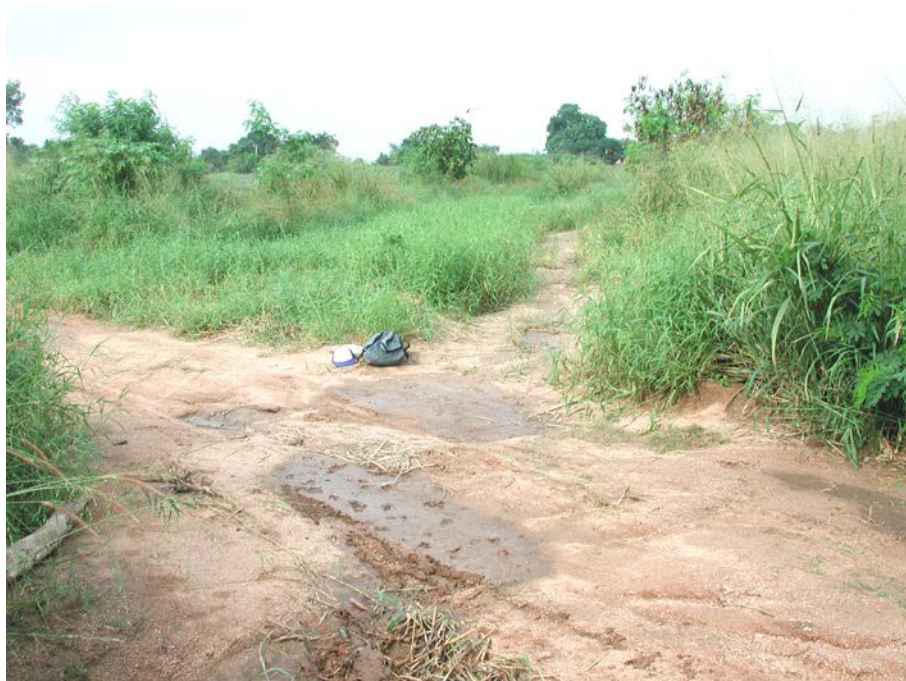
Fig. 5.4 The trail of soil flow to the pond shown in Fig. 5.3
